### 1. Objective

This document describes the manual burglary attempts according to ELOT EN 16230:2011 that have been performed on a security door with the assignment *Porta Block ROCK-15*. The tests were performed to examine if the door complies with the requirements in order to be classified in resistance class RC 4 according to the provisions of ELOT EN 1627:2011.

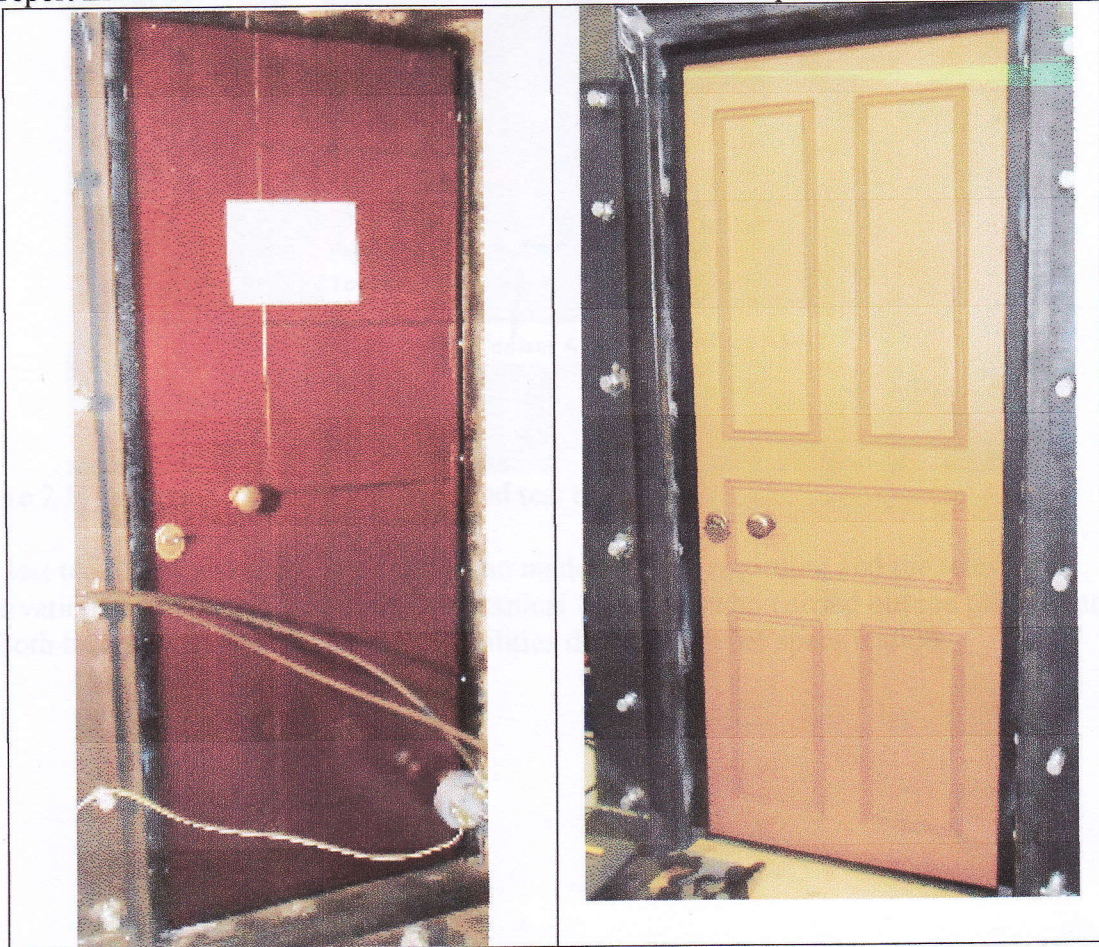
Figure 1 Test specimen for the pre-test and the main test (front side)

According to ELOT EN 1627:2011 two test specimens are required, one for the pre-test, which shall be the same as the one in the static test, and one for the main test. Figure 1 shows the two test specimens. The dimensions and other details of the specimens are described in test report EMK-TR022014 to which reference is made in this report.

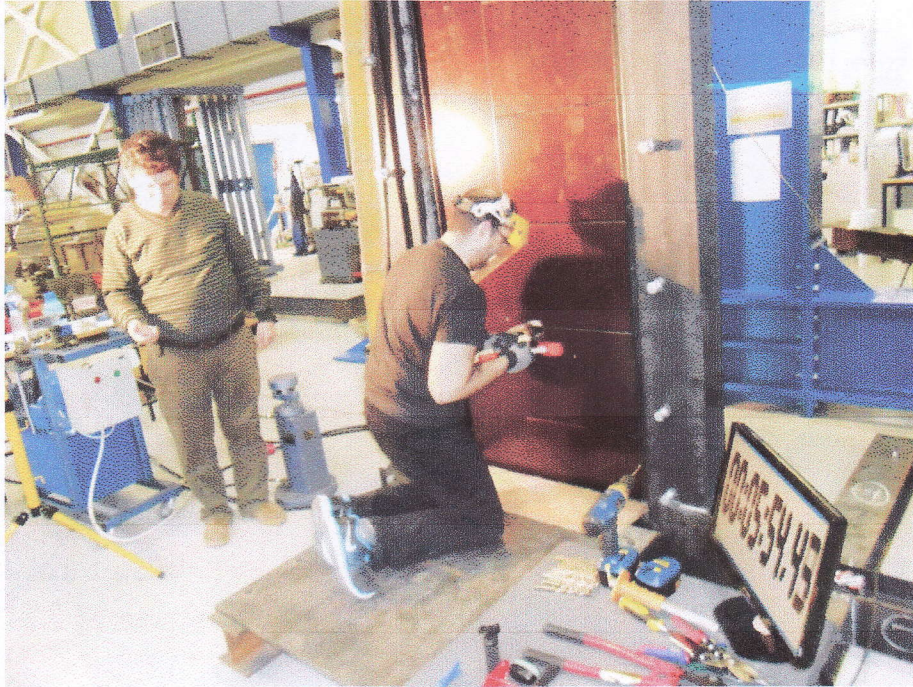
Figure 4 Execution of the pre-test

The pre-test was executed after the static test on the same specimen as in this test. The execution was on the 21/02/2014. Before the test a total test time of 10 minutes was displayed on the screen. At test start the computer chronometer was triggered so that the screen displayed the remaining test time. The total test time of the pre-test was accordingly 10 minutes, while the resistance time 2.5 minutes. The attack side was the front side and attack area the body of the door. The pre-test was fully recorded with a video recorder. The temperature during the pre-test was 26<sup>0</sup> C and the relative humidity 45%. During the pre-test there was not possible to open the tested door or make an opening (Figure 4). However, the pre-test allowed an evaluation of the effectiveness of the tools used.

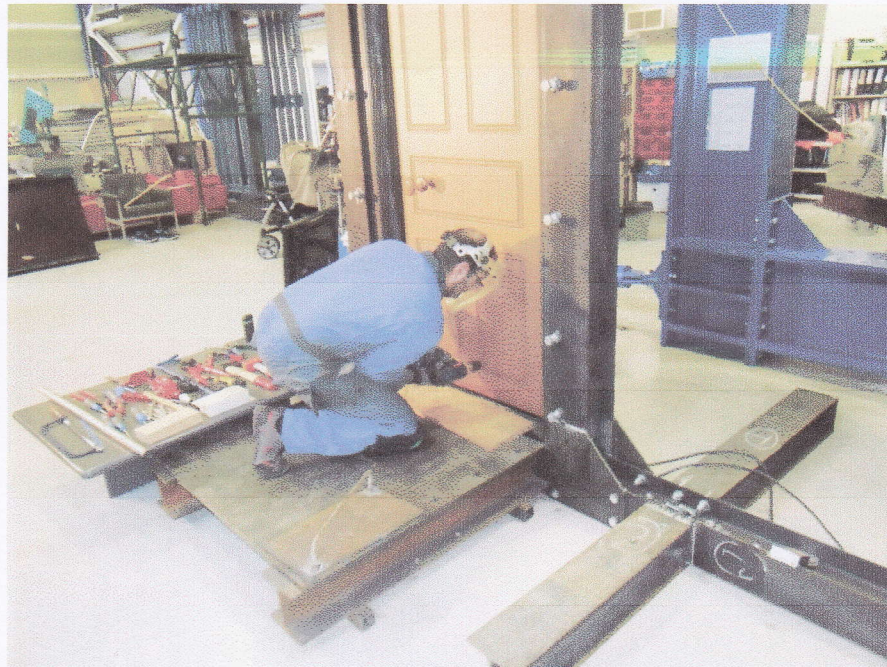
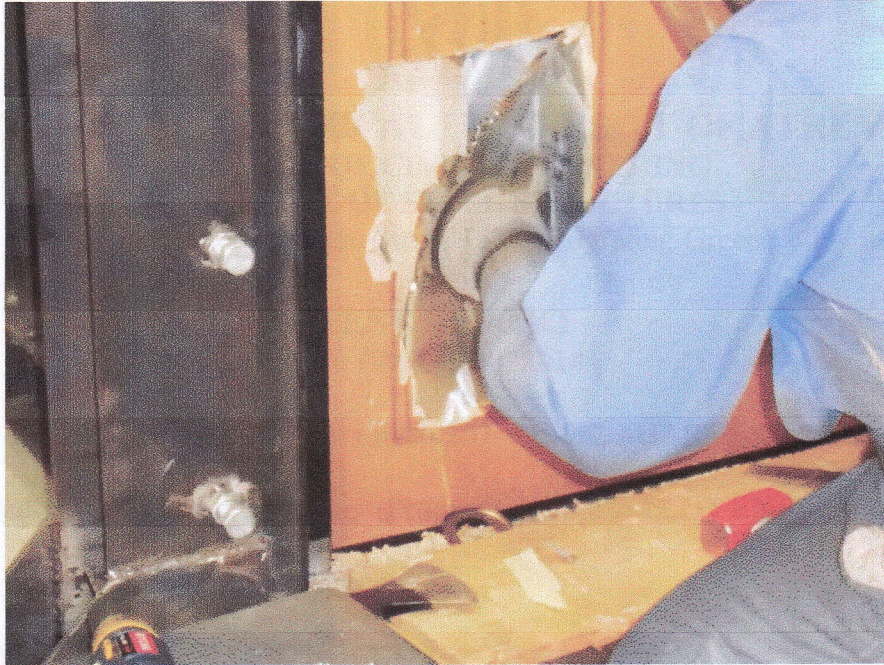
Figure 5 Execution of the main test at following resistance times: a) 4 minutes, b) 10 minutes, c) 12 minutes

Figure 5 Execution of the main test at following resistance times: a) 4 minutes, b) 10 minutes, c) 12 minutes (continued)

Initially holes were drilled in the door and subsequently it was tried to make an accessible opening using template E1, a rectangle 400x250x20 mm, as described in the specification. The total test time was kept at 30 minutes. However, the resistance time was prolonged to 14 minutes to examine if it would be possible to open the door or make the opening. However, both were not possible, even after 14 minutes resistance time. Figure 5 shows photos during the test.

Figure 5 Execution of the main test. Following resistance time of 14 minutes
